SPECIFIC DEFECTS REPORT

Relating to Wall Dampness

Modern Apartment

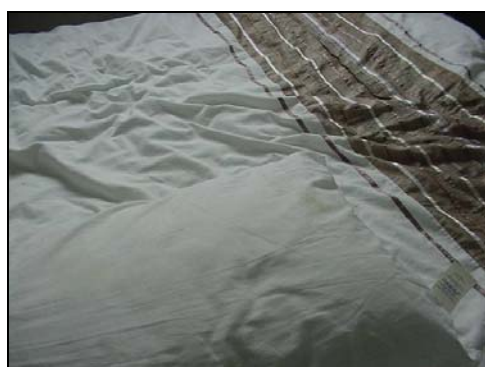
Mould to Pillow

The property has extensive mould to the external walls (only visible to the top of the main bedroom wall at the time of our inspection) and the shower curtain.

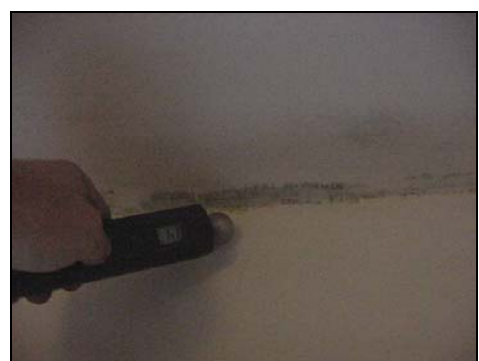
Mould

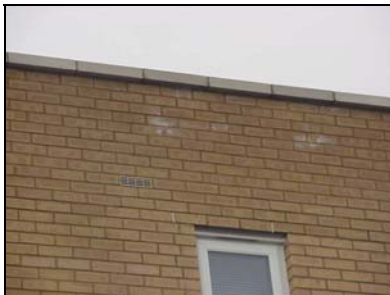
Efflorescence was noted to the brickwork. Efflorescence gets its name from concentrated salt deposits forming a crystalline layer which some say look like small flowers.

Efflorescence is where a white dust is deposited on the surface; this is where moisture will dissolve soluble salts from building materials such as calcium sulphate, which then evaporates through the permeable brick surface and the salts will be left behind forming deposits leaving a white dust on the walls. This is a certain sign that there is dampness in the brickwork. Expanding salt crystals in these locations result in a fracture to the material, which results in spalling, as mentioned above.

Efflorescence visible on parapet walls

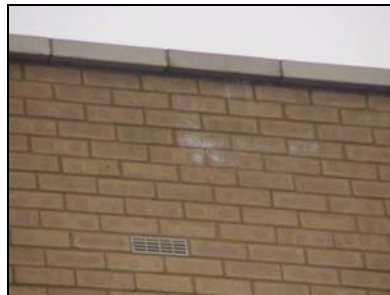
Efflorescence. Also note the weep holes to the lintels above the windows

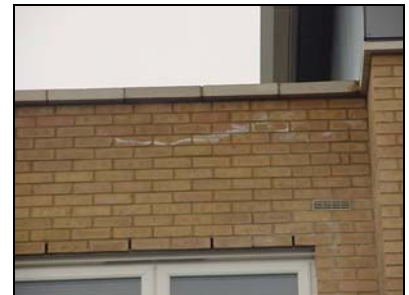
Adjoining properties Efflorescence
