ENGINEERS REPORT / SPECIFIC DEFECTS

Relating to Cracking to the Rear of the Property

**Ground Floor Apartment within a Large
Early Victorian Property in London**

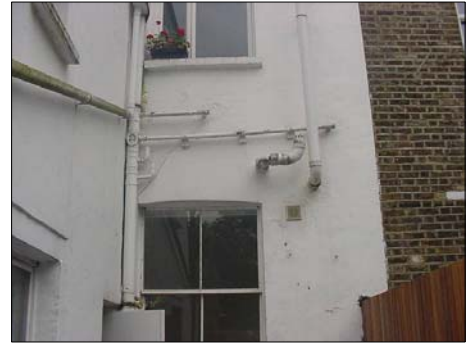
Diagonal cracking to left hand side of window

1. Externally to the subject property diagonal cracking of approximately one and a half metres ranging from 1mm to 8mm with a depth range of approximately 10mm – 40mm, the majority of which is in the 10mm – 15mm range, indicating that the minority of the crack is also into the brickwork. The cracking looks to have been repaired previously.

ACTION REQUIRED: We would recommend that the render is opened up in this area to check the type and condition of the lintel.

If this is a timber lintel depending upon its condition it may be necessary to replace it.

If it is a brick soldier course lintel that has slipped then it needs to be secured in place, i.e. packing or a supporting metal lintel.

Whilst opening up the render you should also check to see if the cracks transfer through the bricks. We found when checking the depth of the raking crack that the majority of it was render thickness, with approximately a quarter of it going deeper than we would expect; indicating the possibility of some brickwork damage.

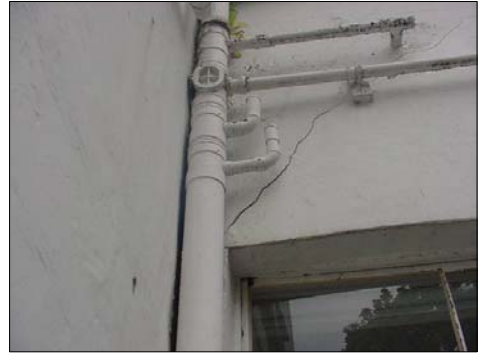
2. We noted hairline cracking over the adjacent kitchen window that looks to have been repaired previously.

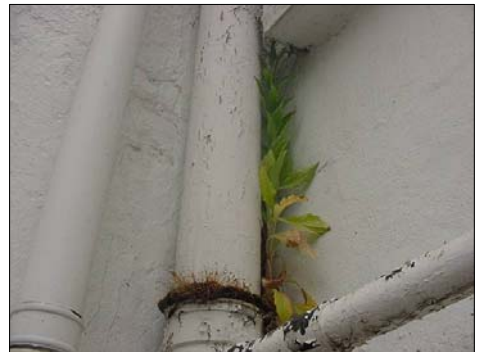
In our discussions with the owner she advised that the gutters had been replaced. We would assume that deterioration had been caused to the render and possibly the brickwork before this by the discharging of rainwater down the face of the property.

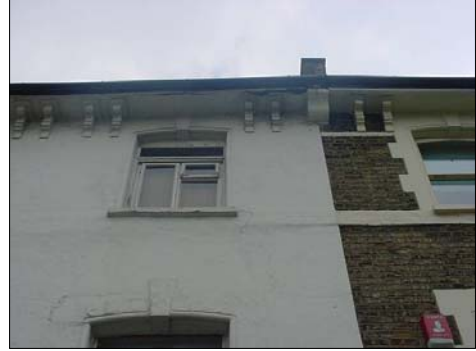
6. We also reviewed the front of the property, which is also rendered and we noticed a defective soffit and fascia indicating possibly that the guttering is still leaking in this area.

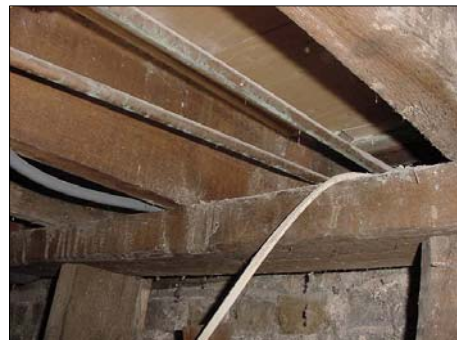
9. We did access the cellar area; the majority of the ceiling was clad but we were able to see a small selection of floor joists within an access hatch within the cellar. What we could see looked in reasonable condition.

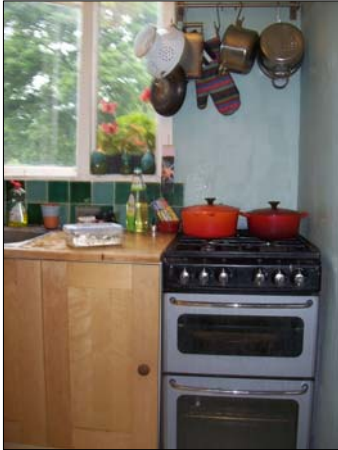
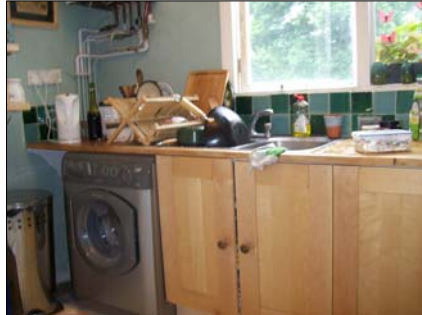
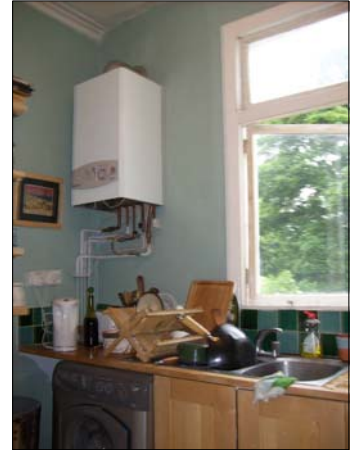
10. We have been forwarded these three photos of the first floor apartment by the client. From our inspection of the photos they do not show any signs of internal cracking, even though cracking can be seen externally.

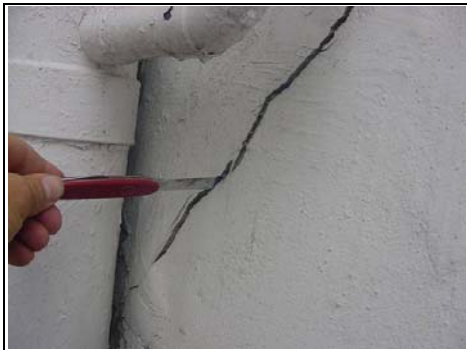
Checking depth of crack -
Bottom of crack

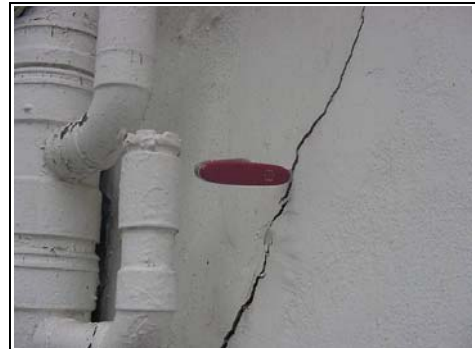
Checking depth of crack -
Lower middle section

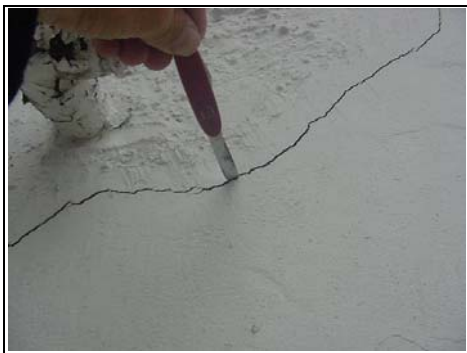
Checking depth of crack -
Upper middle section

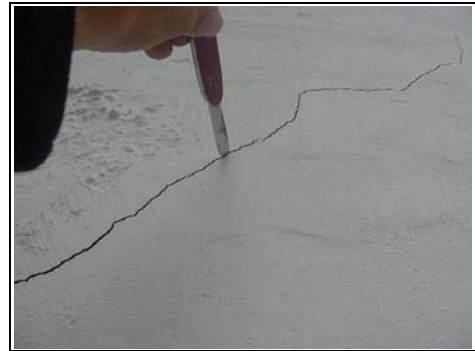
Checking depth of crack –
Top section

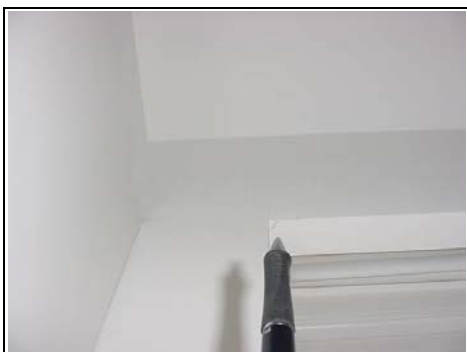
Bedroom – Minor hairline crack
due to drying out of internal
finishing material

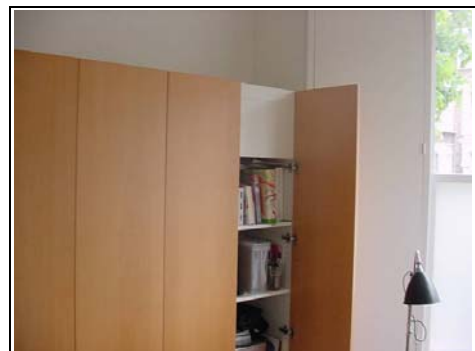
Adjacent cupboard is lined, so we
did not have access to the wall
structure.
