ENGINEERS REPORT / SPECIFIC DEFECTS

Relating to Cracking to the Rear of the Property

**Ground Floor Apartment within a Large
Early Victorian Property in London**

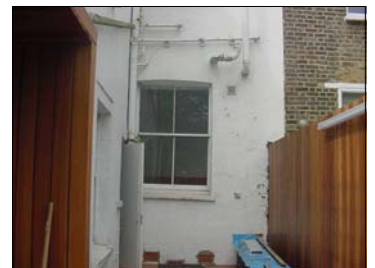
Low level rear view

Diagonal cracking to left hand side of window

1. Externally to the subject property diagonal cracking of approximately one and a half metres ranging from 1mm to 8mm with a depth range of approximately 10mm – 40mm, the majority of which is in the 10mm – 15mm range, indicating that the minority of the crack is also into the brickwork. The cracking looks to have been repaired previously.

3. Externally we noted that the soil and vent pipes showed signs that they are leaking quite badly with a vegetation growth, which are immediately next to the widest part of the crack, which we feel will be causing additional problems with the freeze / thaw cycle.

ACTION REQUIRED: We would recommend that the render is opened up in this area to check the type and condition of the lintel.

If this is a timber lintel depending upon its condition it may be necessary to replace it.

Whilst opening up the render you should also check to see if the cracks transfer through the bricks. We found when checking the depth of the raking crack that the majority of it was render thickness, with approximately a quarter of it going deeper than we would expect; indicating the possibility of some brickwork damage.
